MILLSFIELD POND, MILLSFIELD

EXISTING CONDITIONS: PANORAMA

MILLSFIELD POND, MILLSFIELD
PHOTOSIMULATION PANORAMA

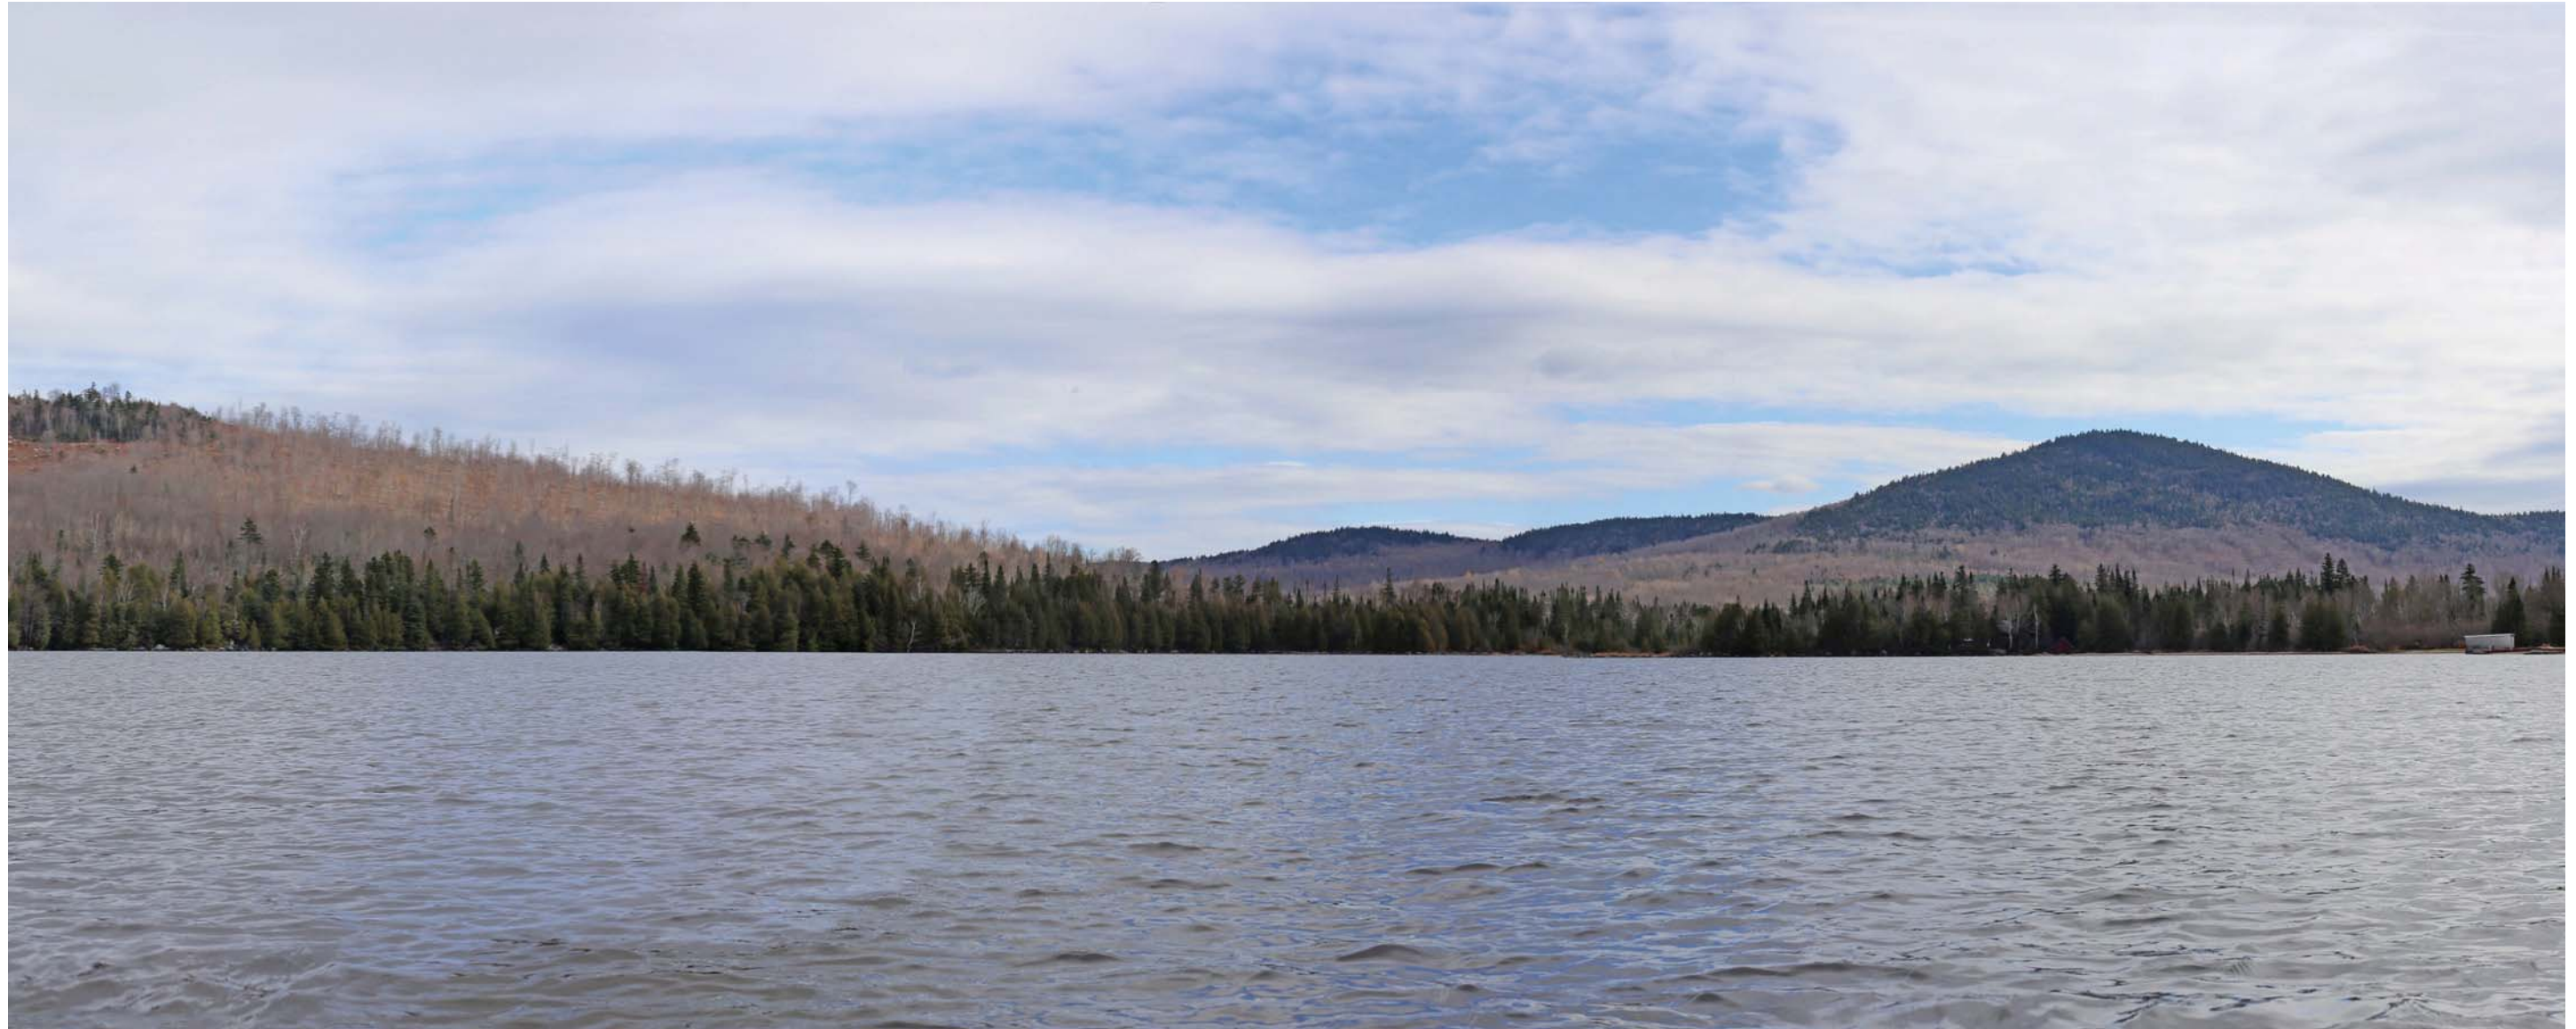
PHOTOGRAPH	Date and time: 10/30/13 at 11:30am	Location: 44.768367° N, -71.264550° W	Viewing Direction: East
	Distance to visible structures: 1.06 to 1.30 miles	Number of transmission structures visible in the photosimulation: 2	
	Camera Focal length (50mm equivalent): 35mm	Camera Make/Model: Canon EOS 6D	Photo Source: LandWorks

VIEW DESCRIPTION
View is from the water near southern shoreline of Millsfield Pond. Signal Mountain is visible above the proposed transmission corridor on the right side of the image.

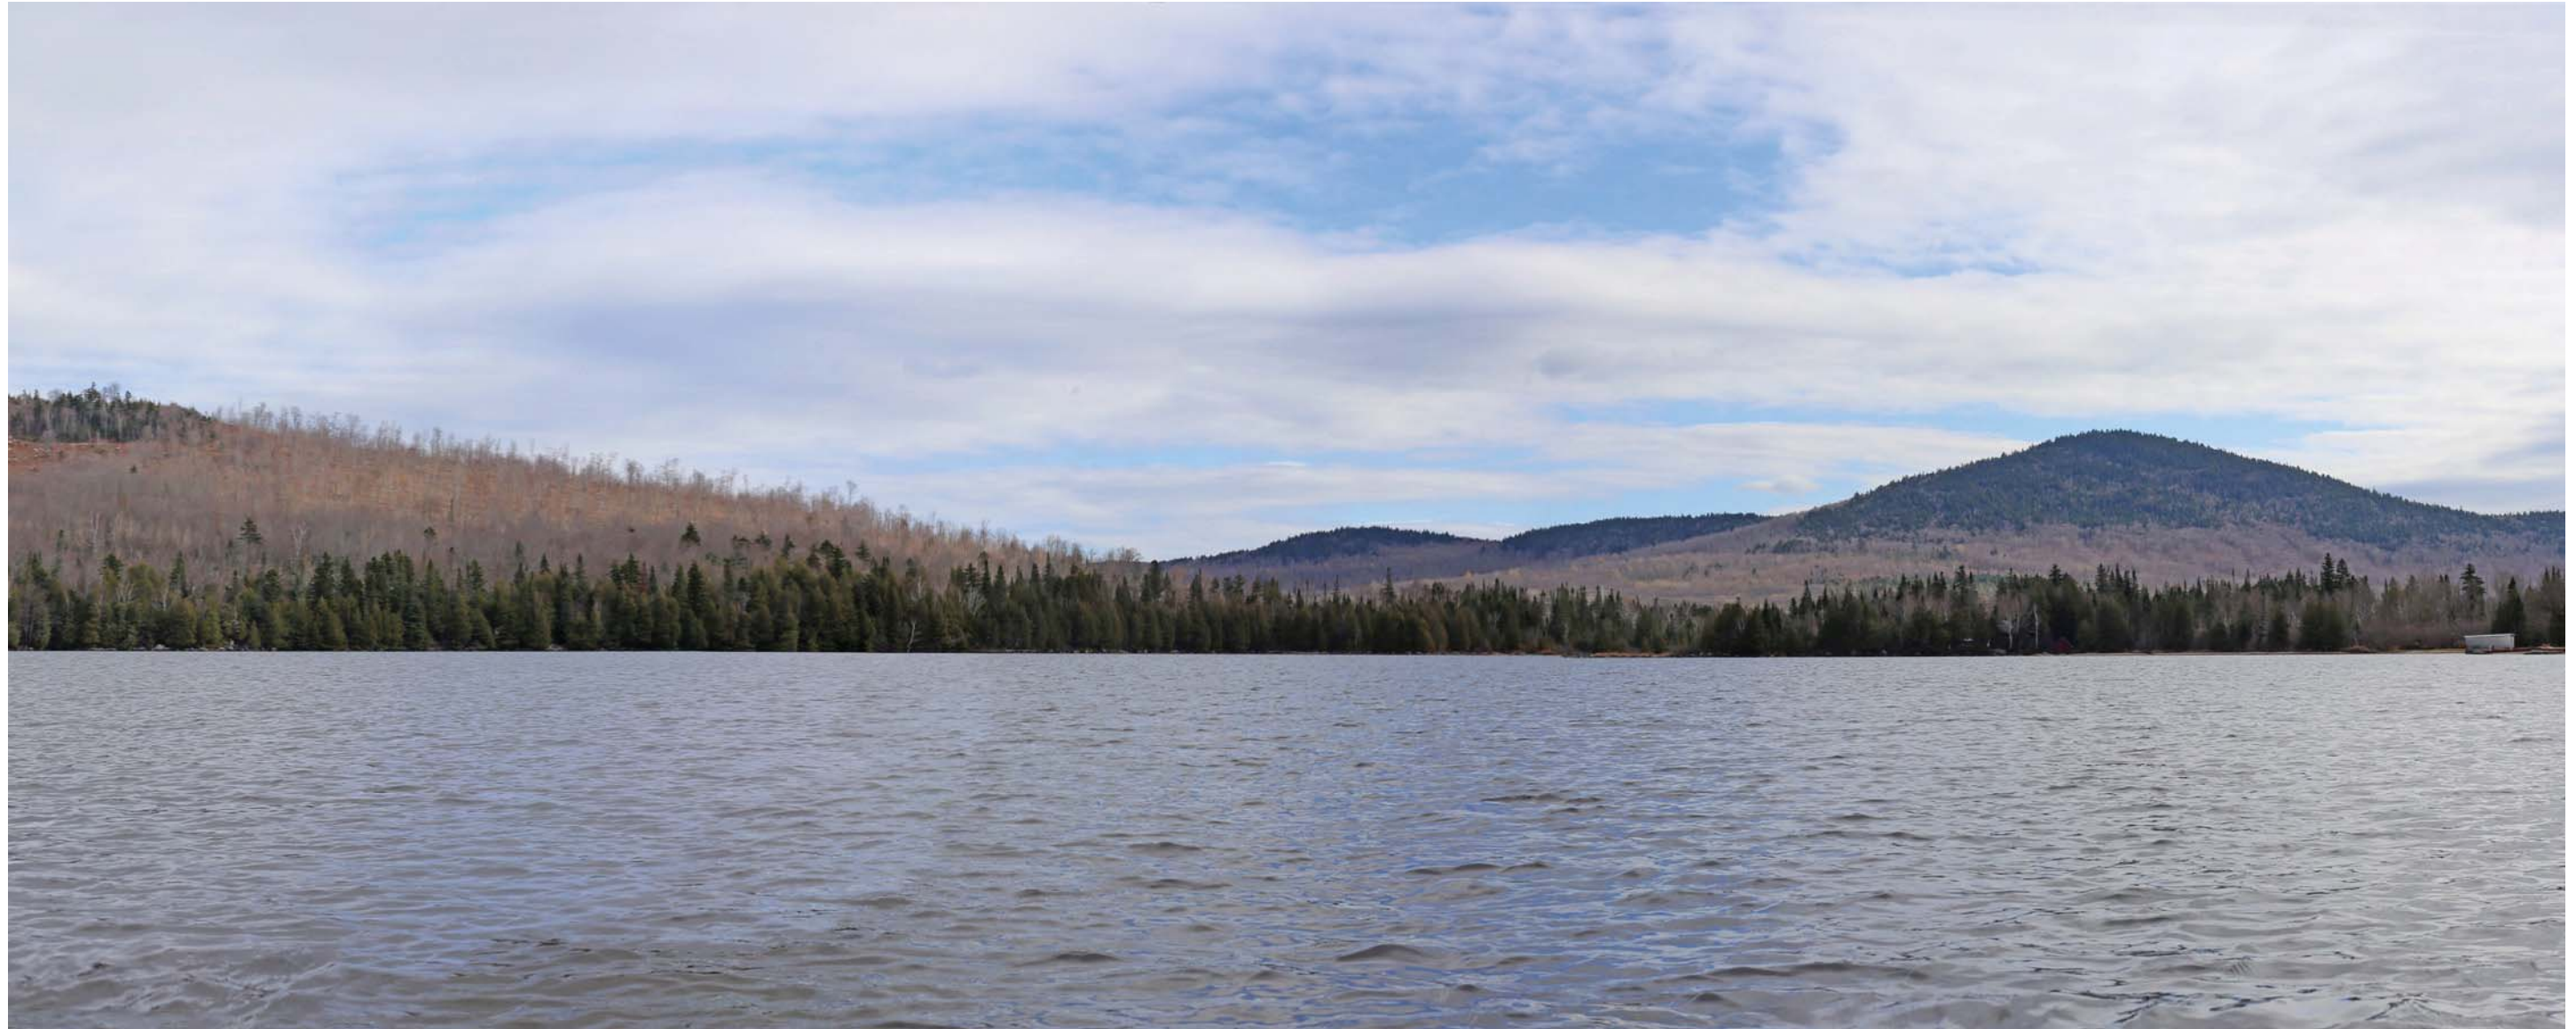
EXISTING	PROPOSED	
TRANSMISSION LINE	115-kV structure type	N/A	
	Height range of visible 115-kV structures	N/A	
	320-kV structure type	N/A	Galvanized Steel Lattice
	Height range of visible 320-kV structures	N/A	70 - 85 feet
	Right-of-way width	N/A	120 feet

PHOTOGRAPH	Date and time: 10/30/13 at 11:30am	Location: 44.768367° N, -71.264550° W	Viewing Direction: East
	Distance to visible structures: 1.06 to 1.30 miles	Number of transmission structures visible in the photosimulation: 2	
	Camera Focal length (50mm equivalent): 35mm	Camera Make/Model: Canon EOS 6D	Photo Source: LandWorks

VIEW DESCRIPTION
View is from the water near southern shoreline of Millsfield Pond. Signal Mountain is visible above the proposed transmission corridor on the right side of the image.

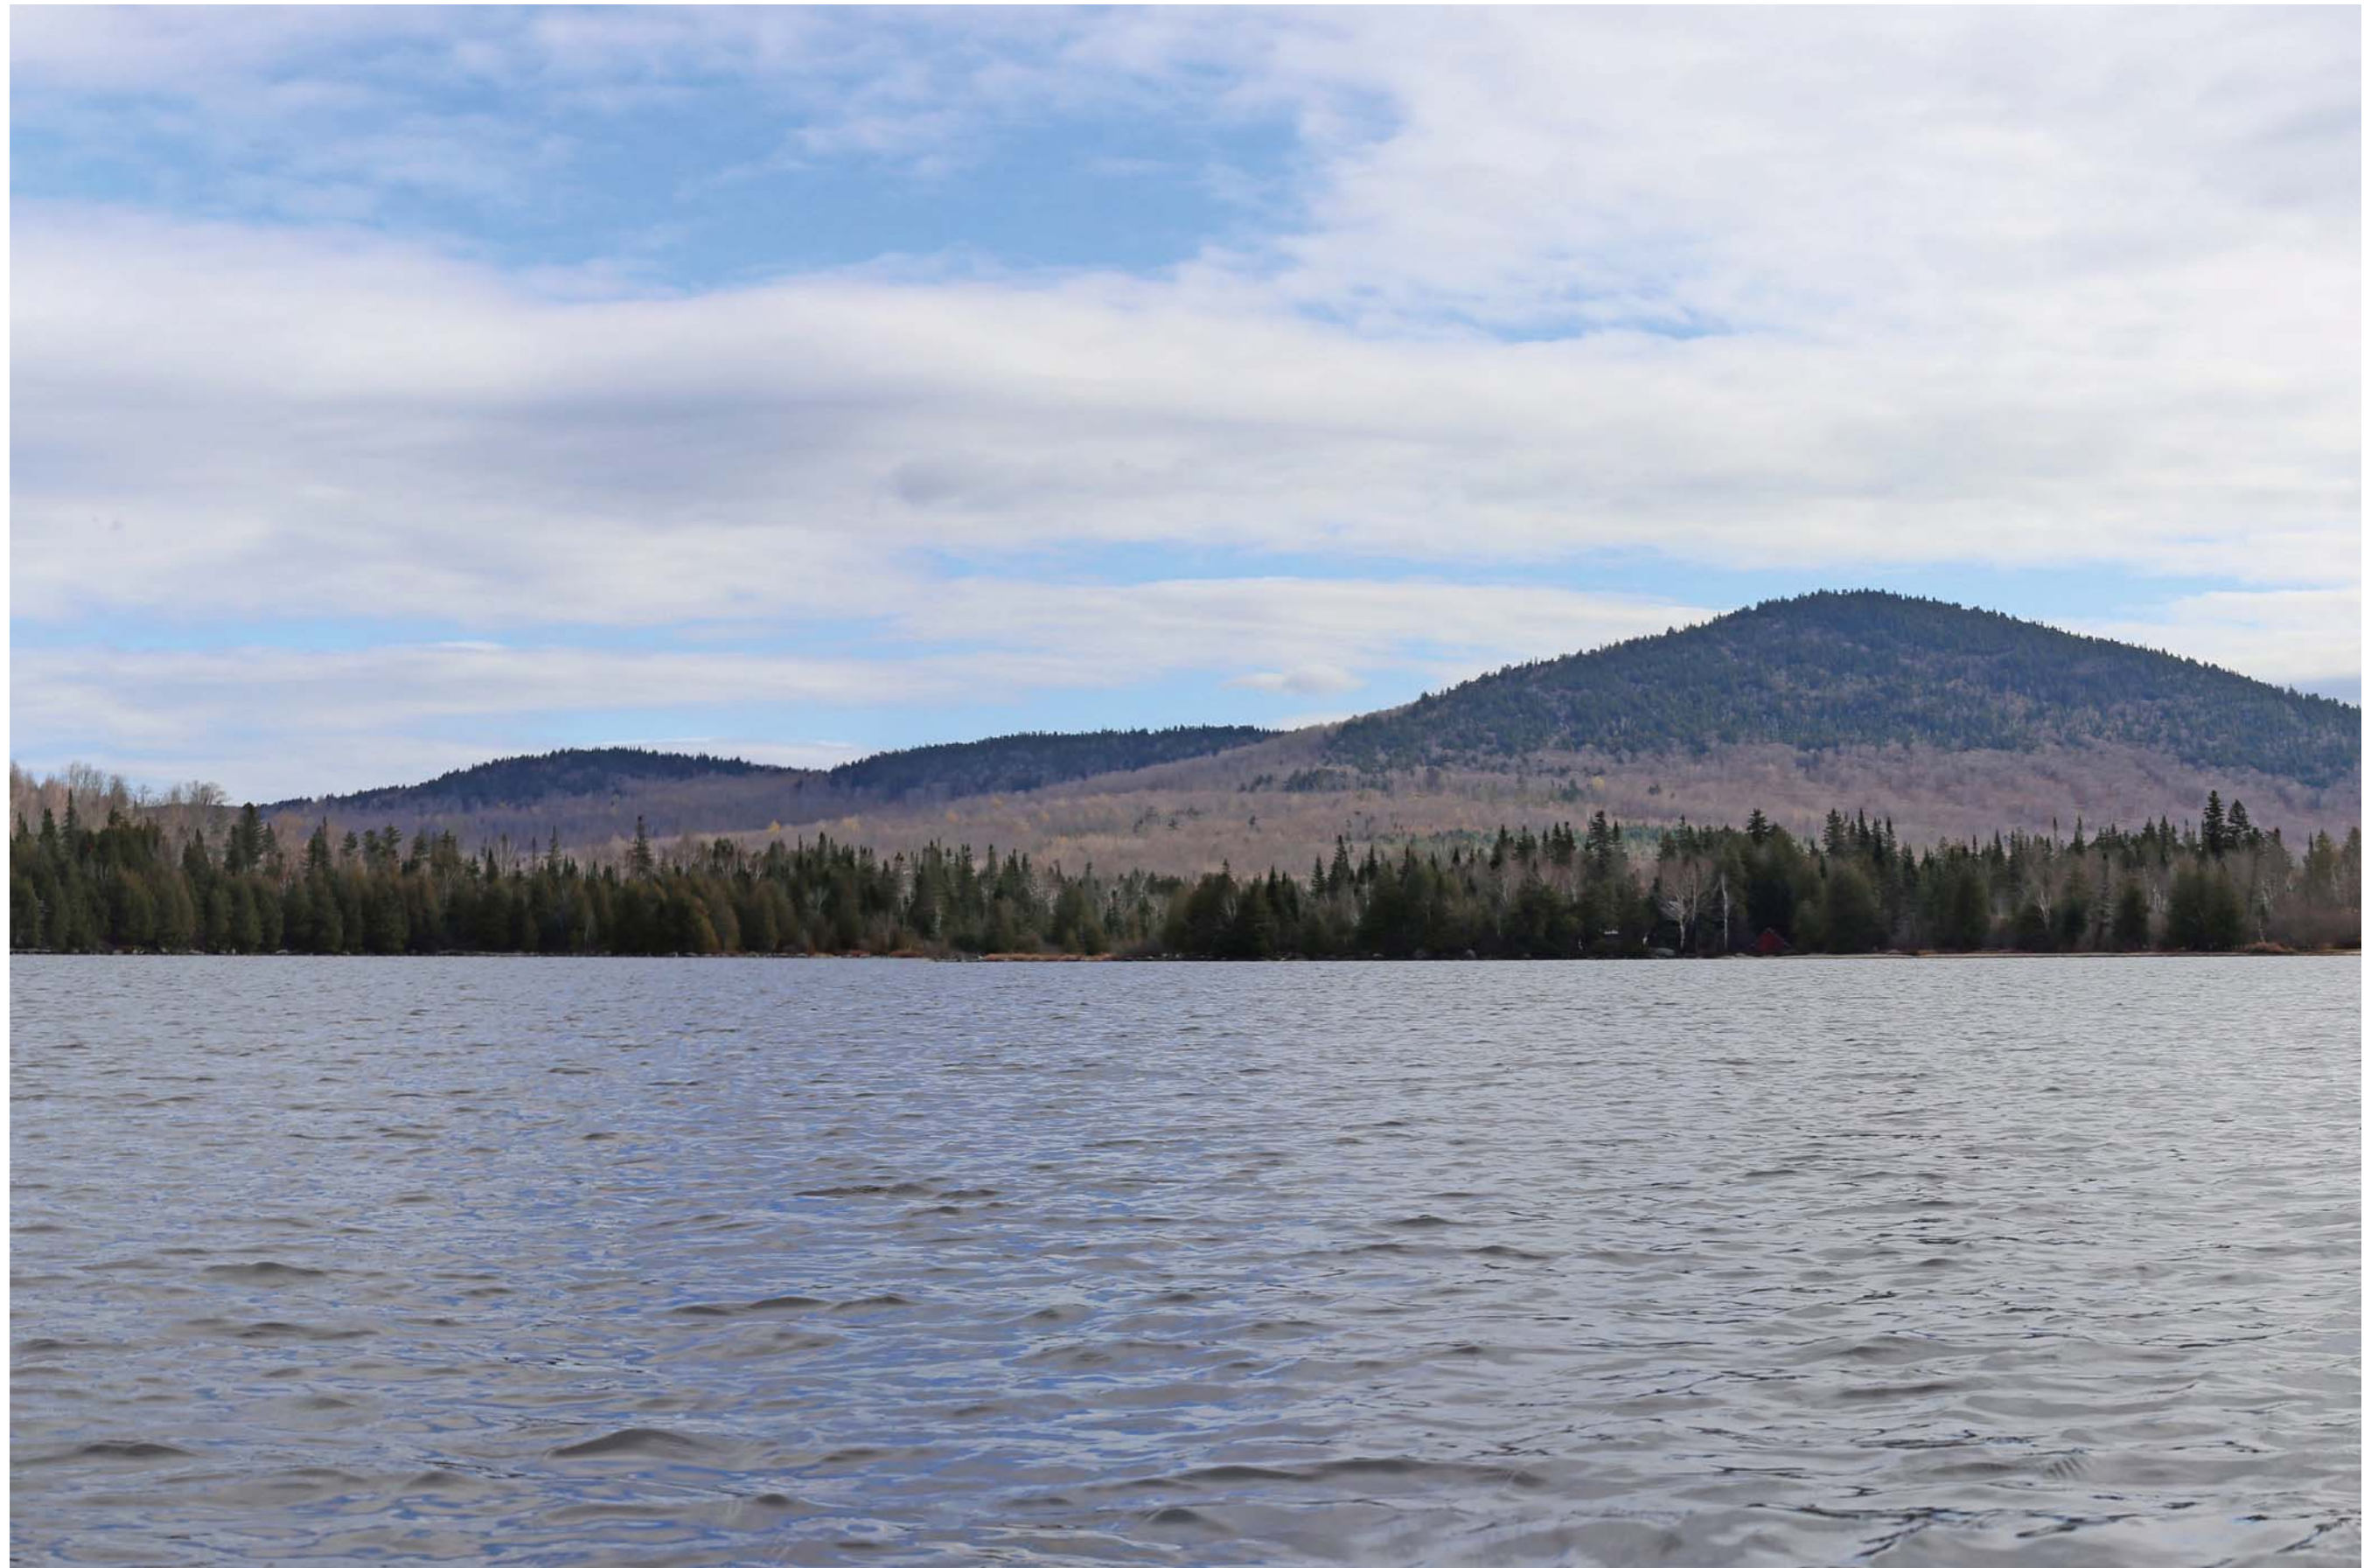
MILLSFIELD POND, MILLSFIELD
EXISTING CONDITIONS: NORMAL VIEW

When printed on 11x17" paper, viewer should hold this image approximately 17" from eye to replicate actual view.

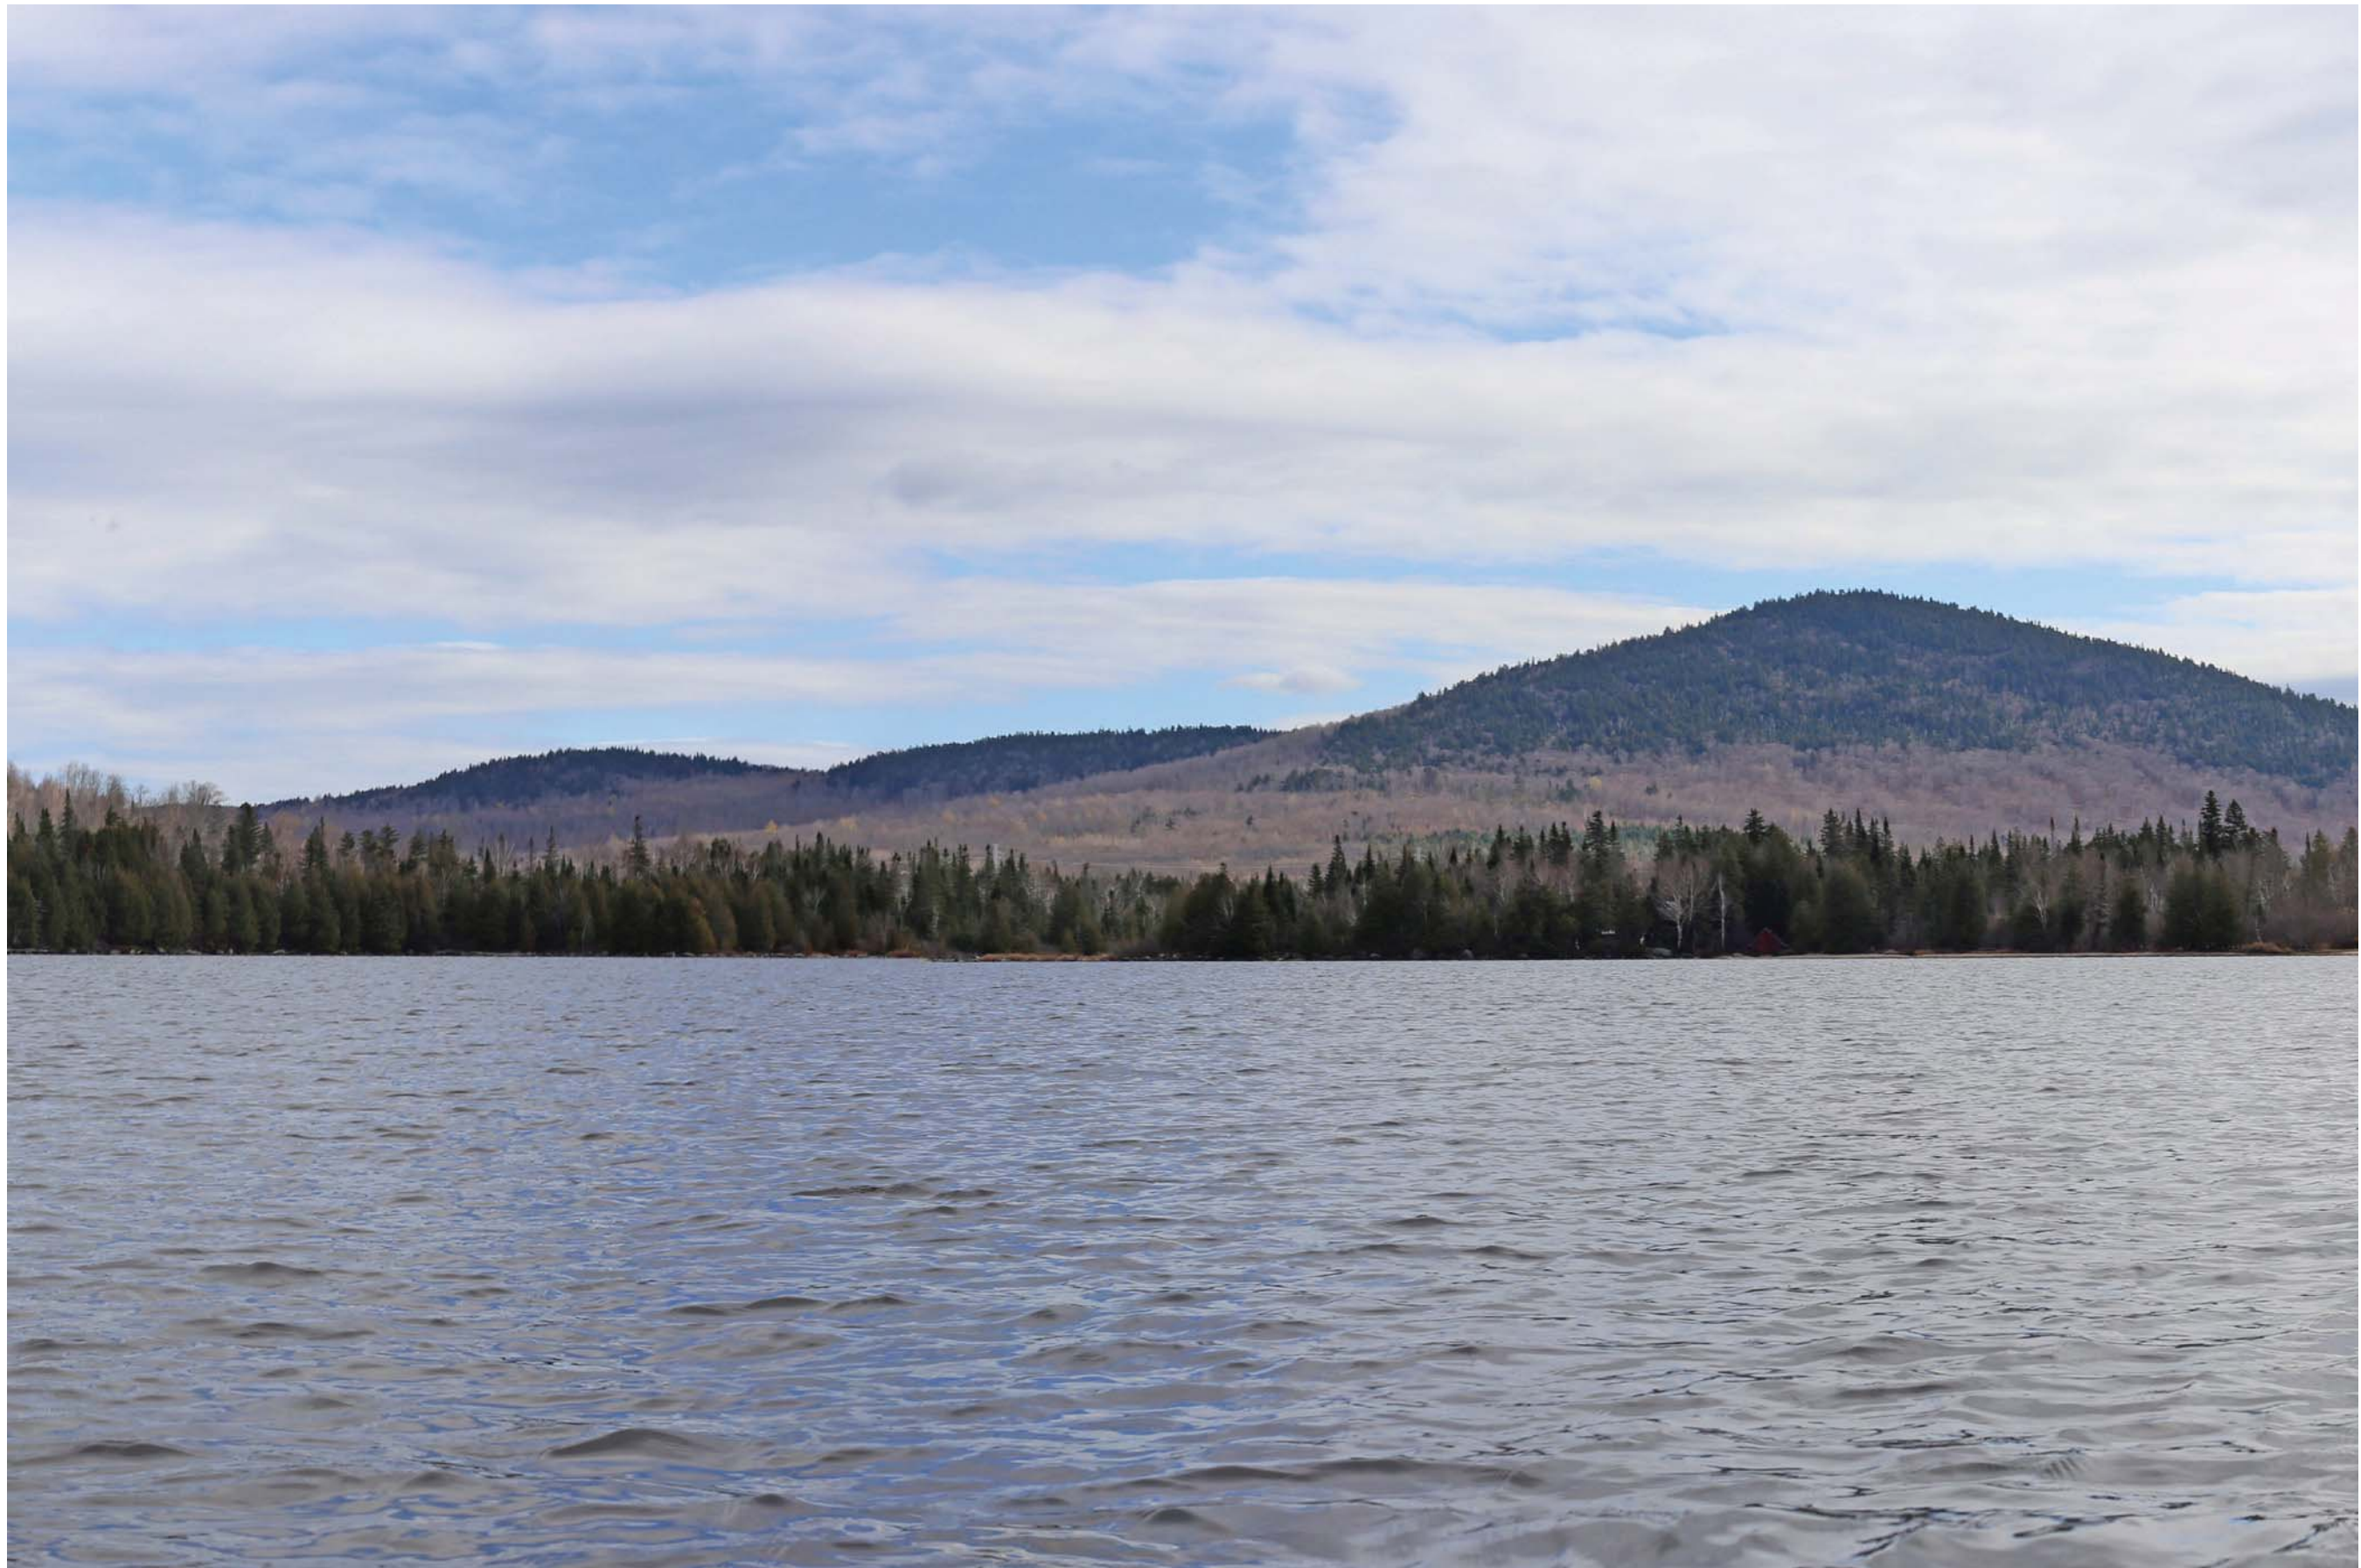
MILLSFIELD POND, MILLSFIELD
PHOTOSIMULATION: NORMAL VIEW

When printed on 11x17" paper, viewer should hold this image approximately 17" from eye to replicate actual view.
